# Service Bulletin

## Service Bulletin No. 070

### Alternator Model ALV-9510R Rotor Shaft O-Ring and Spacer Replacement

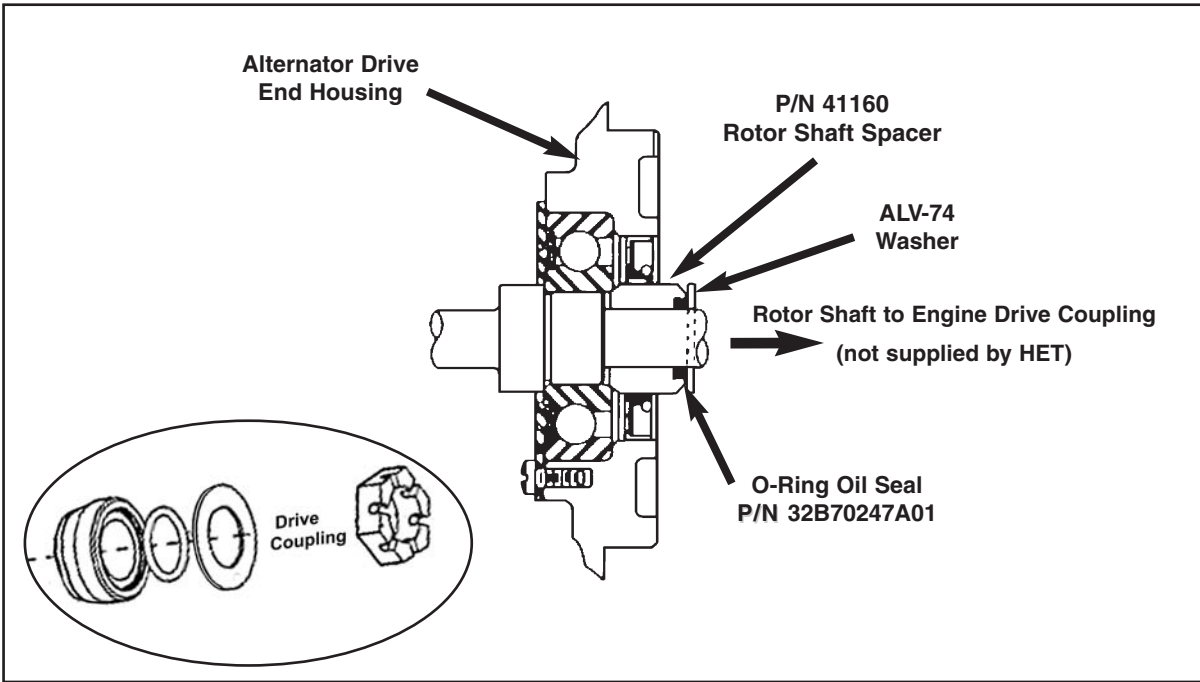
**NOTE:** The engine drive gear coupling is not part of the ALV-9510R alternator delivered by HET (refer to Fig 1). Continental Motors, Inc. (CMI) and other manufacturers produce the engine drive gear coupling and have instructions for removal and installation. Refer to the latest revision of CMI maintenance manual M-0 for drive coupling service information.

Figure 1 - ALV-9510R Alternator Rotor Shaft Spacer, O-Ring & Washer Stack

- (3) Disassemble the alternator only to the extent that will allow replacement of the O-ring and rotor shaft spacer. Refer to Fig. 1.
    - (a) Remove and discard the woodruff key, HET P/N X-0260.

- (b) Remove the large washer, HET P/N ALV-74.
    - (c) Remove and discard the existing O-ring and rotor shaft spacer, HET P/N ALV-0210.
  - (4) Assemble the rotor shaft spacer and O-ring on the alternator rotor shaft.

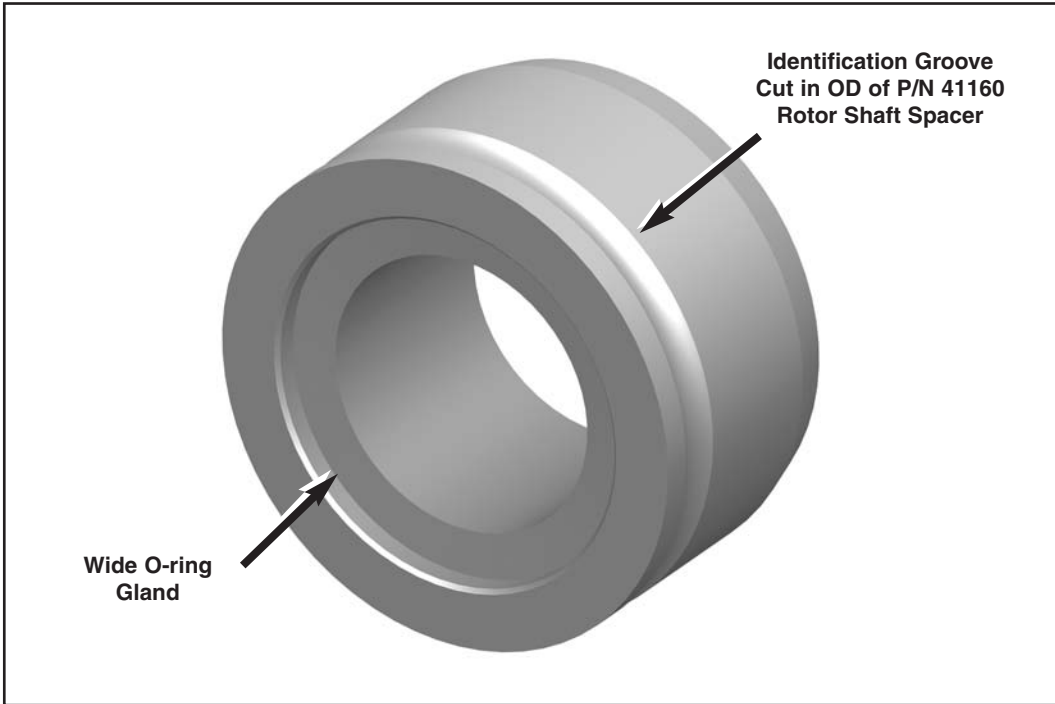
Figure 2 - P/N 41160 Alternator Rotor Shaft Spacer Identification (identification groove and wide O-ring Gland)

- (a) Install the new rotor shaft spacer HET P/N 41160 (will have an identification groove on the OD, refer to Fig. 2), with the O-ring gland facing outward.
