# Service Bulletin

## Service Bulletin No. 054

### **Alternator P/N ES-13070-1 Fan Replacement**

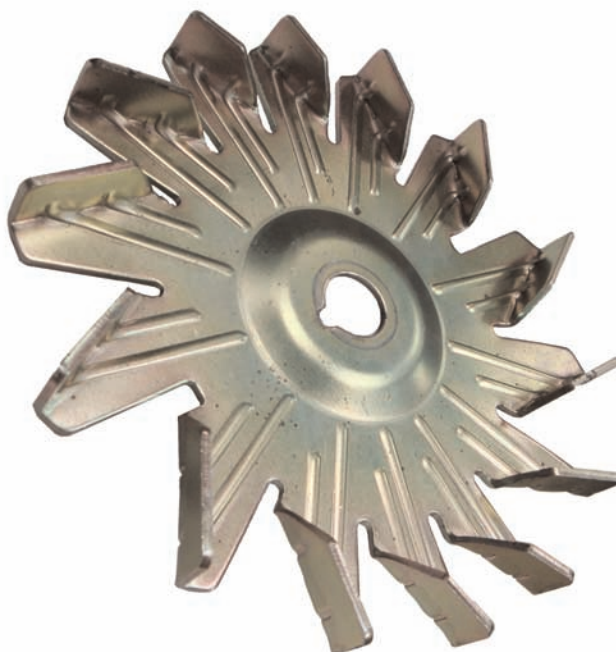
- (1) It has been discovered that P/N ES-13070-1 alternators manufactured by Kelly Aerospace and Hartzell Engine Technologies using a P/N 40397 steel fan may have a condition which could allow the fan blades to crack and potentially separate from the alternator.
- (2) Should the steel fan blades crack and separate from the alternator, damage may occur inside the engine compartment and/or the fan blades may exit the aircraft by piercing the engine cowling.
- (3) This condition may appear in P/N ES-13070-1 alternator's using a P/N 40397 steel fan, S/N J032184 through S/N H-L090932 inclusive. Kelly Aerospace S/N's will not have the H- prefix.
- (4) Notify the STC holder and applicable aircraft manufacturers of the alternator condition and effectivity.
- (5) Regulatory action is not expected.

**Figure 3 - P/N 40397 Steel Fan Identification  
(Remove Fan & Discard)**

- (1) The corrective action for this service bulletin requires that the steel fan P/N 40397, two spacers, and lock washer be removed and replaced with a new aluminum fan P/N 40995, new pulley spacer P/N 40760, new fan spacer P/N 40915, and new lock washer P/N 40523-4. Replacement may be performed with the alternator installed on the aircraft if adequate access is available.
- (2) To remove the original steel fan (P/N 40397), use the following instructions:

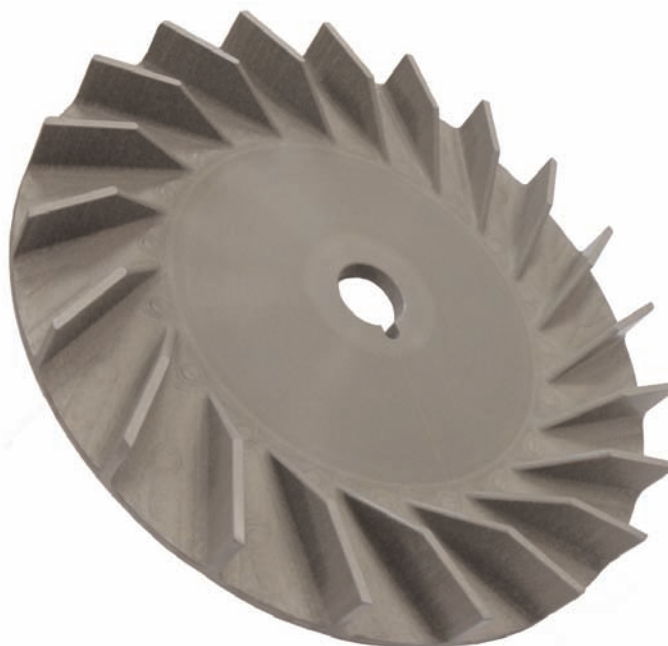
**Figure 4 - P/N 40995 Aluminum Fan Identification  
(Replacement Fan)**

- (1) This Service Bulletin provides Instructions for Continued Airworthiness (ICA).
- (2) This Service Bulletin is being issued to require the replacement of the existing steel fan P/N 40397, with an improved aluminum fan P/N 40995, on P/N ES-13070-1 alternators.
