ES10024-1 (TCM P/N 656802) ALTERNATOR SLIP RING END HOUSING CRACKS

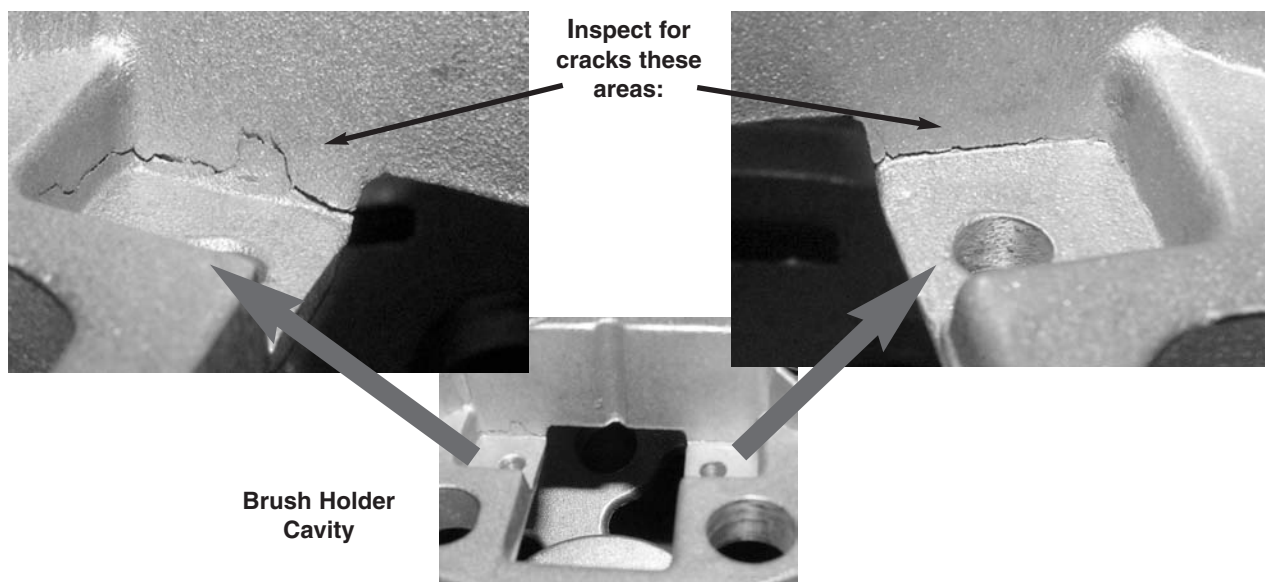
Figure 1 - Alternator Slip Ring Housing (at brush holder)

It has come to the attention of Kelly Aerospace Energy Systems, that a small group of ES10024-1 (TCM P/N 656802) alternators may experience cracks in the slip ring end housing. These cracks are related to a fixture used in the original machining of the housing and not to service use or time. This condition, left uncorrected, may eventually lead to the loss of alternator function.

3. Remove the nut and field wire attached to the brush holder assembly. *(Alternator left on or taken off.)*
4. Remove the alternator from the engine in accordance with instructions contained in the applicable engine or aircraft maintenance manual. *(See note above.)*
5. Remove the two screws that hold the brush holder assembly in the slip ring end housing. Carefully remove the brush rack assembly from the slip end housing taking care not to allow brushes to spring out and fall as they may break or chip.
6. With the brush holder and brushes removed, use a 3x magnifying glass and inspect the brush holder cavity for cracks in the area shown in Figure 1. If cracks exist, continue with instruction 7. If there are no apparent cracks, continue with instruction 8.

7. Reinstall the brush block assembly (unit must be complete for warranty consideration) and replace the ES10024-1 (TCM P/N P/N 656802) alternator with a new or serviceable unit. *If drawing from inventory, make sure that the new unit does not have an affected serial number.* (Continue with step 9.)
8. Before installing the brush holder assembly insert insulated wire to retain the brushes for installation. Reinstall the brush rack assembly and retaining screws. Torque the #10-32 screws 25 to 35 in.-lbs and remove the brush retaining wire to release the brushes. Reattach the field wire and nut removed from the brush holder assembly. Torque nut per the applicable aircraft maintenance manual instructions.
9. Reconnect electrical power and perform an engine run to check the security of installation and to check performance of the alternator. If good, proceed to the "Return to Service" below.
