# SERVICE BULLETIN

## Service Bulletin No. 075

### Alternator Drive Coupling Inspection

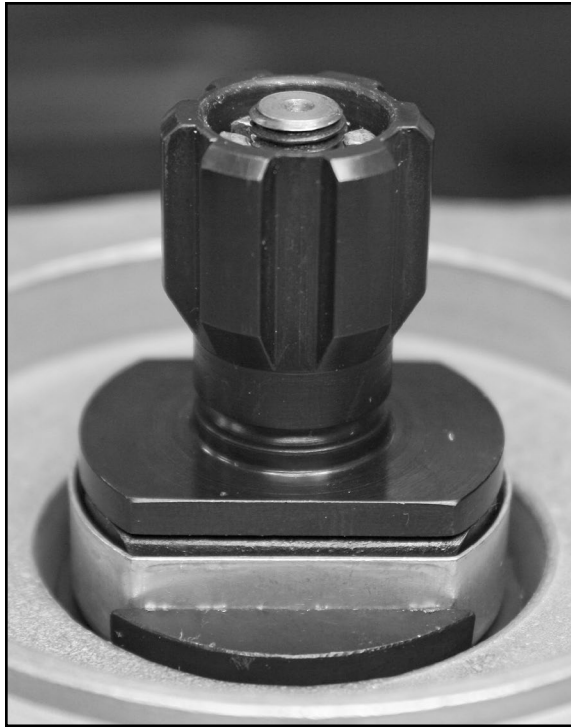
- (3) If the alternator serial number is affected per section 1.A:
  - (a) Utilize applicable aircraft maintenance manual to remove the alternator and inspect the alternator gear drive (Item Number 4, Table 2 – Materials Required) for correct alignment. Refer to Figures 1 & 2 - Alignment Inspection.

Figure 1 - **CORRECT** Alignment

- 1) If **INCORRECT** alternator gear drive alignment is observed, continue to Corrective Action section 3.B.(1).
    - 2) If **CORRECT** alignment is observed, the affected alternator may be re-installed on aircraft and re-inspected in accordance with section 3.A.(3) every fifty (50) hours time-in-service until a total of two hundred and fifty (250) hours time-in-service is reached from release date of this SB.

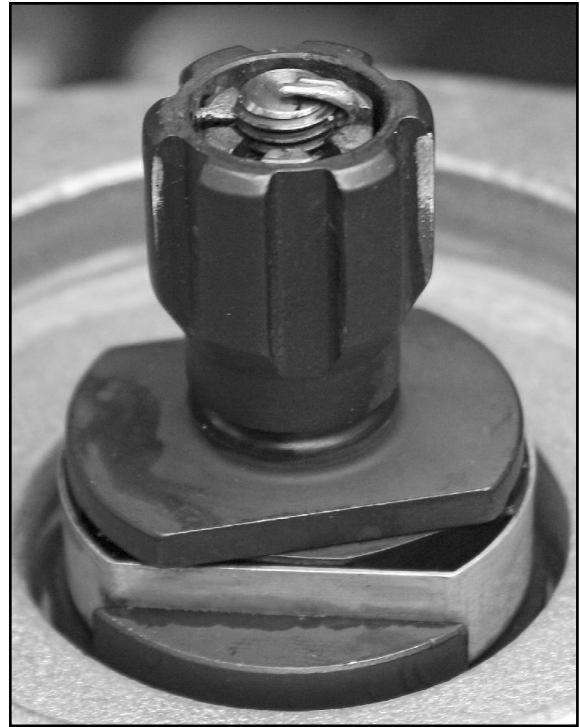
- (1) HET has discovered alternators containing part numbers listed in section 1.A. of this SB contain a condition that has potential, if not corrected, to introduce foreign object debris (FOD) into the engine cavity.

Figure 2 - **INCORRECT** Alignment

- a) When a total of 250 hours time-in-service is reached from the release date of this SB, continue to Corrective Action section 3.B.(1) of this SB regardless of inspection findings.
