SERVICE BULLETIN

Service Bulletin No. 077

Alternator Nameplate Inspection

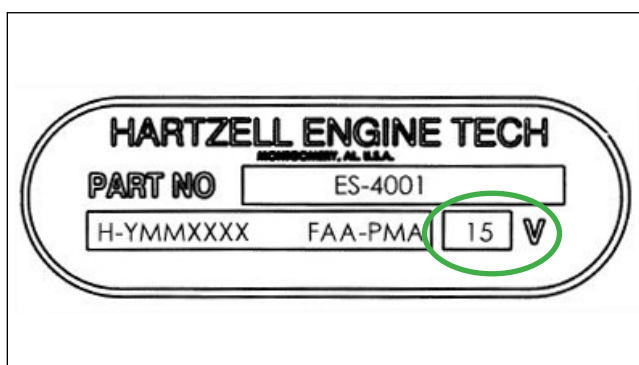
Figure 1 - **CORRECT** Voltage Rating

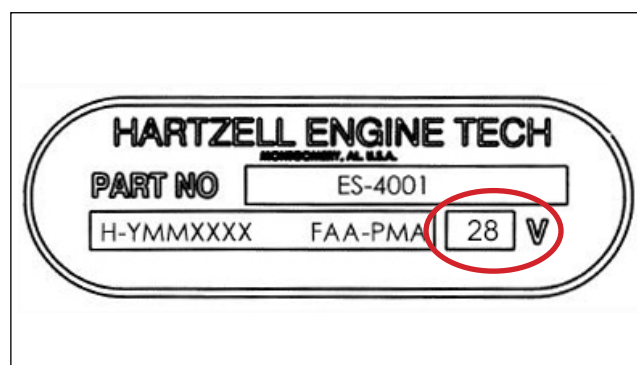
- (1) HET has discovered alternators listed in section 1.A of this SB were shipped with an improper voltage rating displayed on the nameplate.
- (2) The nameplate displays an incorrect rating of 28v. The correct rating should read 15v.
- (3) Operating an affected alternator at 28v could lead to failure of the alternator.

NOTE: Incorrect voltage rating is defined as any voltage found on the nameplate of an affected alternator other than 15v.

Figure 2 - **INCORRECT** Voltage Rating

- (1) Using a non-metallic scraper, remove the nameplate from the affected alternator.
- (2) Clean alternator housing with denatured alcohol prior to installing the new nameplate.
- (3) Install self-adhesive nameplate P/N 50466 containing the correct voltage rating.
