2900 Selma Highway
Montgomery, AL 36108 USA
Tel: 334-386-5400 Fax: 334-386-5450

ALERT SERVICE BULLETIN No. 081

Alternator Castellated Hex-Nut Inspection

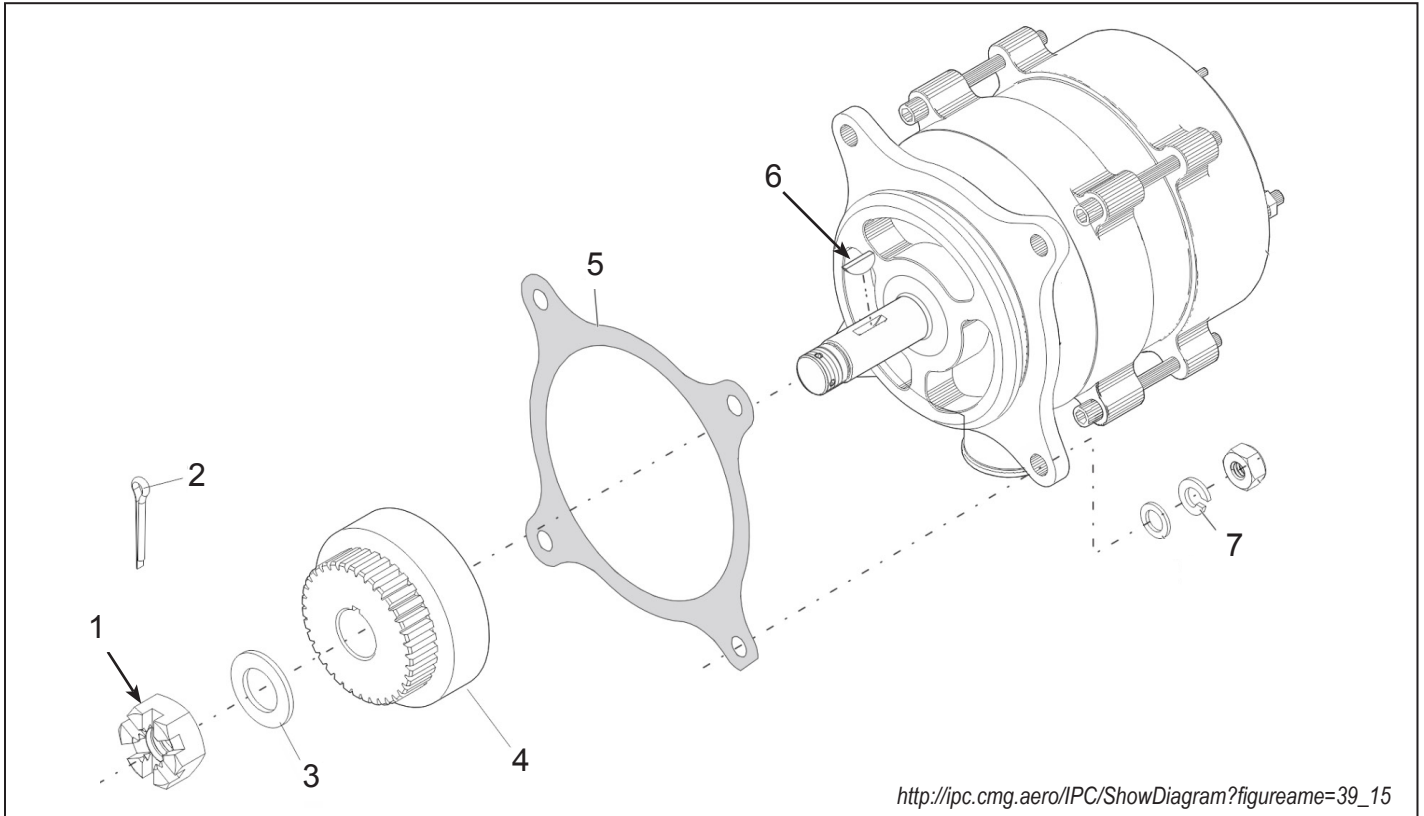
Figure 1 - Alternator, Typical - Continental Aerospace Technologies

- (1) Alternators listed in section 1.A could contain a castellated hex-nut (1, Figure 1) that does not torque flush with the thrust washer (3). This condition could compromise the integrity of the drive coupling retention system.
 - (a) Loss of drive coupling retention may result in engine damage and/or unexpected loss of engine power.
- (2) This ASB is to advise the field of a known condition and to supply inspection criteria to identify affected alternators.

- (5) Remove and discard from alternator; Cotter Pin (2), Castellated Hex-Nut (1), Thrust Washer (3), and Woodruff Key (6). Refer to Figure 1.
- (6) Install new replacement components not affected by this ASB onto the alternator in accordance with applicable engine manufacturer's maintenance manual. Refer to Table 1 - *Materials Required*.

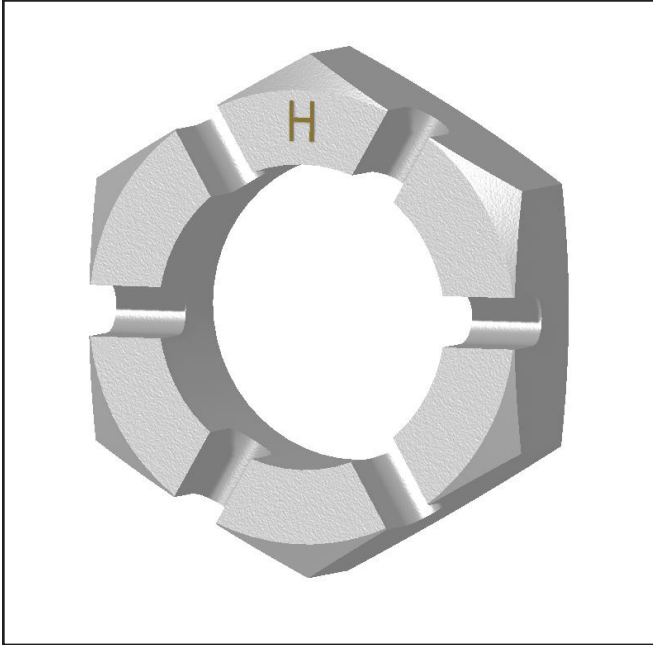
Figure 3 - Laser Etched "H"

- (1) Remove the alternator from the engine in accordance with the latest revision of the aircraft and/or engine manufacturer's maintenance manual.
- (2) Inspect castellated hex-nut (1). If one the following indicators is present, the alternator is in compliance with this ASB. Refer to Figures 3 thru 5.
 - (a) Hex-nut (1) is laser etched with the letter "H";
 - (b) Hex-nut (1) is stamped with a center-punch;
 - (c) A machined groove is present around the hex-nut (1) face.
- (3) If any indicator stated above **is not** present, proceed to 3.B.(4). If one of the indicators stated above **is** present, continue to 3.B.(7).
- (4) Using a .002 in. (.0508 mm) feeler-gauge, measure the gap between the nut thrust face and the thrust washer at each of the six hex-nut flats. Refer to Figure 6.

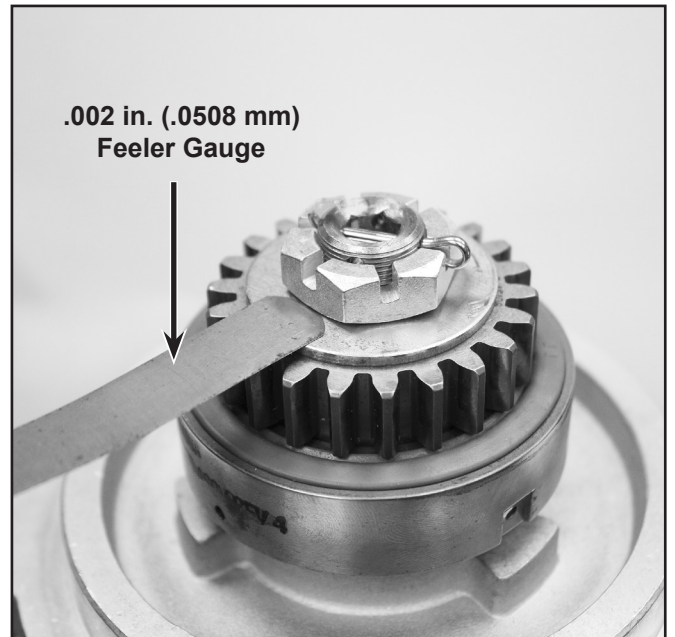
Figure 6 - Gap Measurement

- (a) If the measurement at any nut flat is $\geq .002$ in. (.0508 mm), continue to 3.B.(5).
- (b) If the measurement at each nut flat is $< .002$ in. (.0508 mm), no corrective action is required.
 - 1) Using an automatic center punch, punch the face of the hex-nut (1) so that it will be easily identified for future reference (Refer to Figure 5). Continue to 3.B.(7).
