**SERVICE BULLETIN No. 090**

## **Alternator Thru-Bolts**

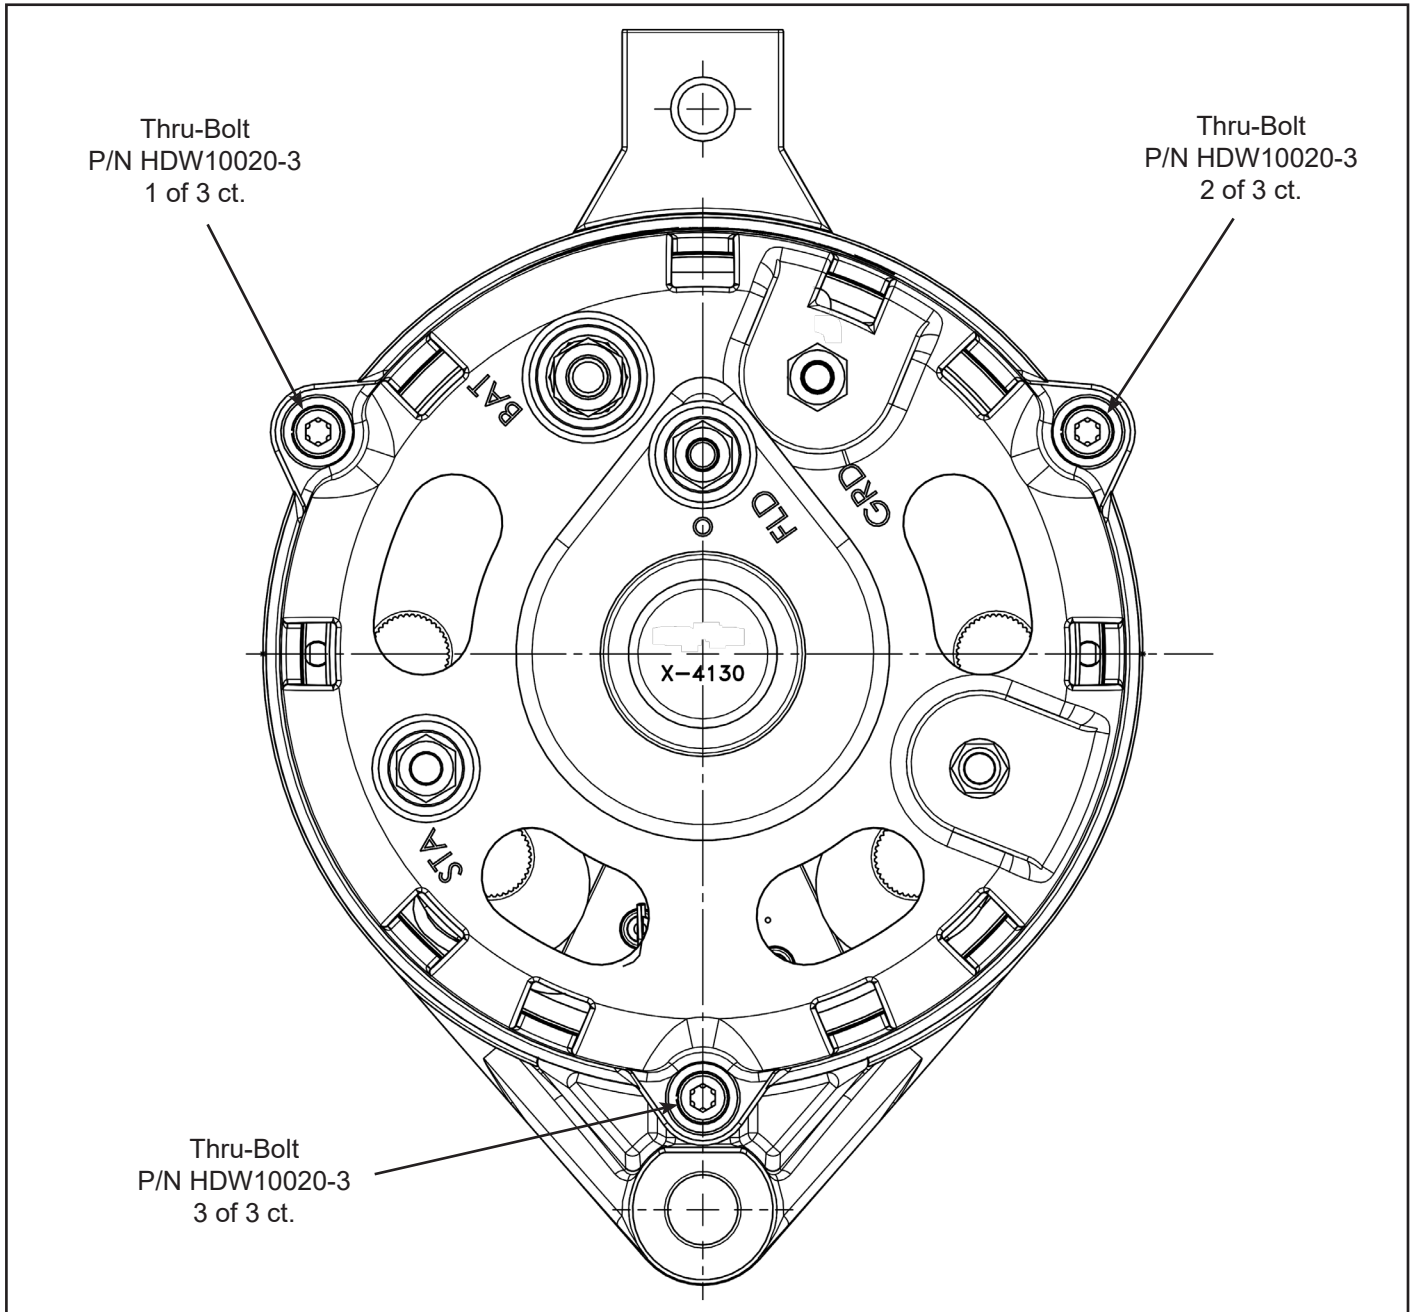
Figure 1 - Thru-Bolt Locations

- (1) Alternator P/Ns listed in Table 1 could contain thru-bolts with inadequate mechanical properties.
  - (a) This condition may result in thru-bolt fracture and loss of clamping force between the alternator drive-end and slip-ring-end housings.
- (2) This SB is to advise the field of a known condition and to supply inspection criteria to identify affected alternators.

- (a) Gain access to the alternator in accordance with the latest revision of the aircraft and/or engine maintenance manual.
- (b) Visually inspect the three (3) thru-bolts (Fig.1) for evidence of cracks, broken safety-cable/wire, and/or sheared bolt heads. If indications are present, proceed to 3.B.2 and replace the alternator prior to further flight.
  - 1) If no cracks, broken safety cable/wire, or sheared thru-bolt heads are present, perform a recurring inspection every 25 aircraft-hours not to exceed one-hundred aircraft-hours from the initial inspection.
  - 2) At an accumulated one-hundred aircraft-hours or at the next scheduled annual aircraft inspection, whichever occurs first, the alternator must be replaced. See **Option 2**.

- (a) Remove the alternator from the engine in accordance with the latest revision of the aircraft and/or engine manufacturer's maintenance manual.
- (b) Install a new, overhauled, or repaired alternator in accordance with applicable engine manufacturer's maintenance manual. Refer to 2.A, Materials Required.
- (c) Reconnect alternator electrical connections and cooling hardware in accordance with applicable aircraft manufacturer's maintenance manual. Continue to 3.C. Return to Service.
