Alert Service Bulletin

Alert Service Bulletin No. 097

Alternator Mounting Flange Inspection

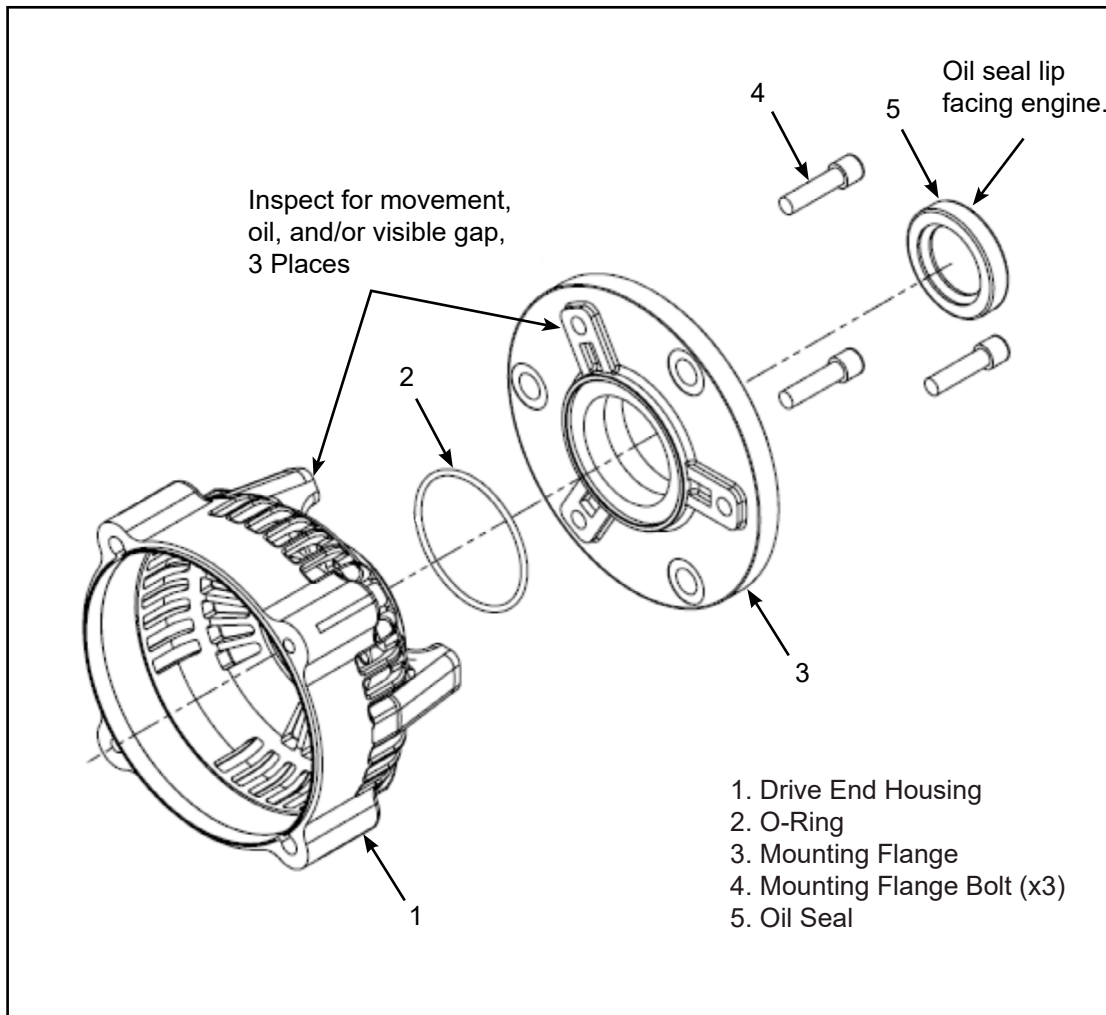
Figure 1 - Alternator Mounting Flange

- (1) Hartzell Engine Tech has discovered that alternator P/Ns referenced in 1.A. may experience a reduction in clamping force at the joint between the alternator drive end housing (1) and mounting flange (3).
 - (a) Loss of alternator mounting flange clamping force may result in loss of engine oil and/or unexpected loss of engine power.
- (2) This ASB is to advise the field of a known condition and to supply inspection criteria to identify affected alternators.

- (1) If a loose condition or oil leak is **not** found
 - (a) Remove affected alternator per applicable aircraft engine and airframe service instructions or maintenance manual.
 - (b) Remove and discard one of three flange bolts (4) securing the alternator to the mounting flange.
 - (c) Apply a mild solvent to a non-metallic bristle brush and remove oil/grease and any cured threadlocker present in the drive end housing threads. Ensure debris does not enter the alternator housing.
 - (d) Apply LOCTITE® 272 threadlocker to one of three drive end housing (1) threads and install one new flange bolt (4) to snug condition.
 - (e) Repeat steps (b) thru (d) for remaining two flange bolts.

- (b) Remove the alternator drive coupling from the alternator per manufacturer's instructions.
 - (c) Remove and discard three mounting flange bolts (4) and separate the mounting flange (3) from the alternator drive end housing (1).

- (m) Install the alternator mounting flange (3) onto the alternator drive end housing (1). Secure with three new mounting flange bolts (4) to snug condition.

- (n) Torque alternator mounting flange bolts (4) to 85-90 in-lbs.
 - (o) Reinstall the alternator drive coupling onto the alternator and perform any required inspections per manufacturer's instructions.
