SERVICE BULLETIN No. 209

Alternator Mounting Bracket Inspection

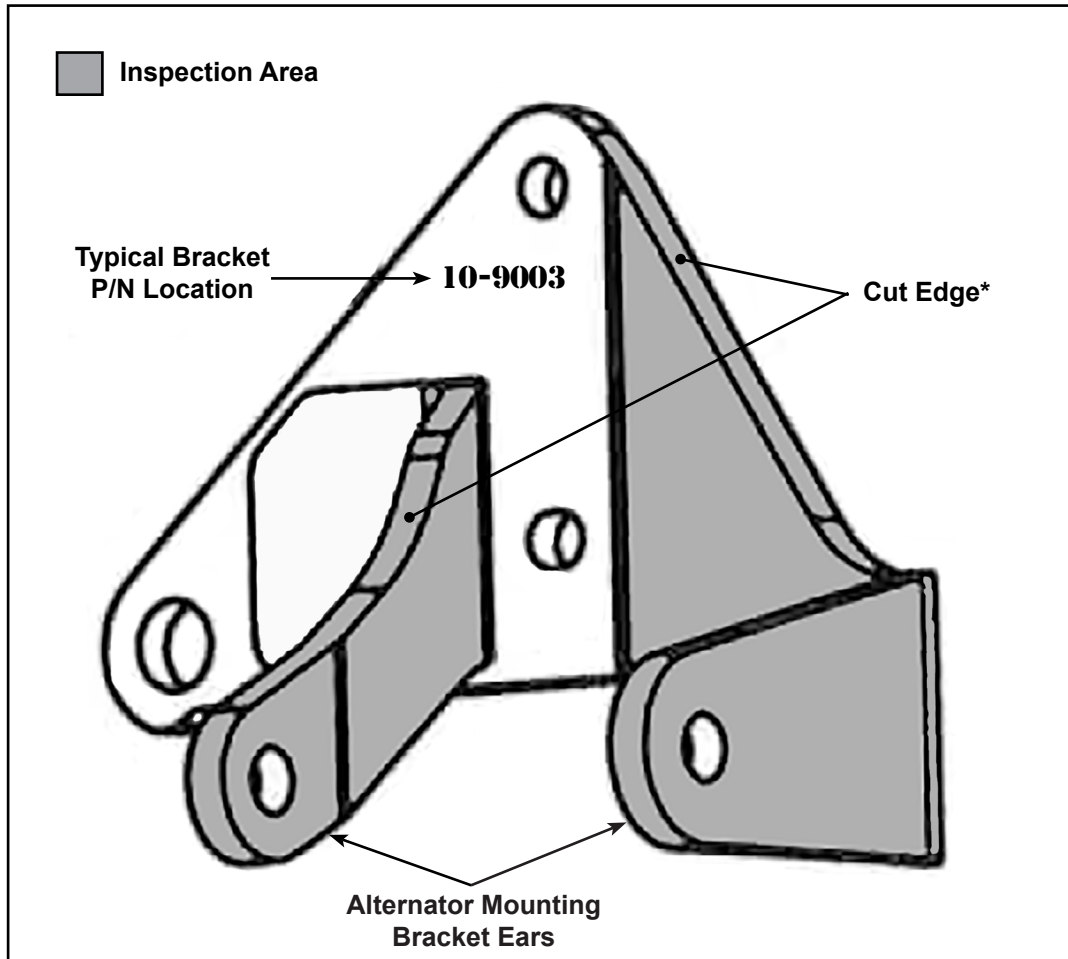
Figure 1 - Alternator Mounting Bracket Inspection Area

- (1) Installed alternators mounting kits listed in section 1.A could contain a cracked alternator mounting bracket P/N 10-9003 due to non-shimmed gaps between the alternator and alternator mounting bracket ears.
- (2) This SB is to advise the field of a potential condition and to supply inspection criteria to identify affected alternators using alternator mounting bracket P/N 10-9003.

- (1) If previous compliance cannot be verified through aircraft or engine maintenance records, use the same references to determine if an affected alternator has been installed. Refer to section 1.A, Effectivity.
- (2) If effectivity of the alternator cannot be established using aircraft or engine maintenance records, utilize the applicable aircraft engine maintenance manual to gain access to the alternator and inspect the alternator and alternator mounting bracket against criteria found in section 1.A of this SB.
 - (a) If the alternator **is** affected per section 1.A and alternator mounting bracket P/N 10-9003 is installed (Fig. 1), inspect the alternator mounting bracket ears for stress cracks. See Fig. 1, Inspection Area.

NOTE: Linear machining marks may be visible on the cut edge of the alternator mounting bracket/ears. They do not represent cracks.

- 1) If the alternator mounting bracket **is** cracked, contact HET Product Support for assistance in obtaining a new alternator mounting bracket and shims and continue to 3.B, corrective action.

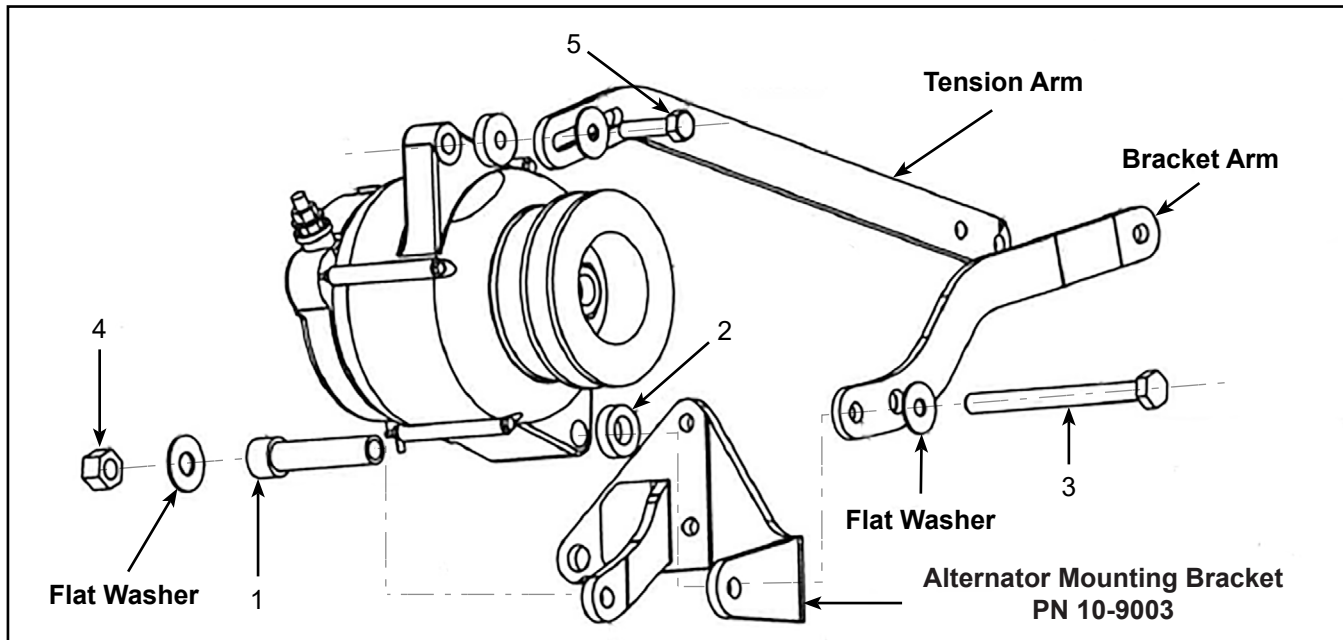
Figure 2 - Alternator and Alternator Mounting Bracket Assembly

- c) Align the alternator and spacers (1) & (2) to one side of the alternator mounting bracket.
- d) Use a feeler gauge and inspect the gap between the alternator mounting bracket ear and spacer.
- e) Record gap measurement.

1: The measured gap should be ≤ 0.007 .

2: If the measured gap is **not** ≤ 0.007 , continue to 3.B, Corrective Action.

- (1) With the alternator, tension arm, and bracket arm in a free state, align alternator pulley and engine drive pulley.
- (2) Press spacers (1) & (2) against the alternator.
- (3) Install shims between the spacer (1) and/or (2) and the alternator mounting bracket until a combined gap between the alternator spacers (1 & 2) and alternator bracket of ≤ 0.007 is achieved.

NOTE: Shims may be split between forward and rear gaps to align the alternator pulley to the engine drive pulley.

- (4) Install a new lock-nut (4) onto bolt (3). Do not torque the lock-nut (4) at this time.

- (5) Using a feeler gage, verify total thickness of gaps is ≤ 0.007 .
- (6) Tension alternator drive belt in accordance with aircraft/engine maintenance manual and service instructions. Torque the bolt (5) to 140 in/lbs and install .032" safety wire.

- (7) Torque the bolt (3) and lock-nut (4) to 160-190 in/lbs.
