Alert Service Bulletin No. 221

Alternator Replacement: Continental O-300 Series Engines Only

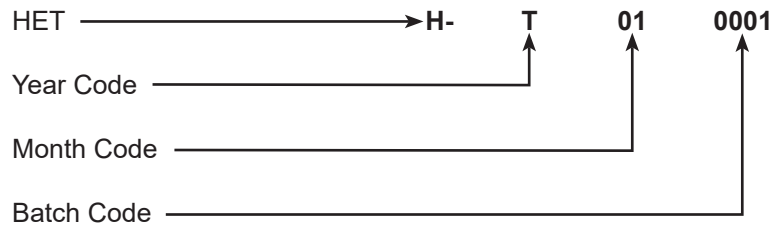
a) Serial Number Identification for H-T thru H-X:

Example above: T=2019, 01=January, 0001=first unit of the month (batch). The year code advances one letter in alphabetical order for each succeeding year. X012176: X=2023, 01=January.
