Alert Service Bulletin No. 224

Alternator Spacer P/N 41151 Inspection

2900 Selma Highway
Montgomery, AL 36108 USA
Tel: 334-386-5400 Fax: 334-386-5450

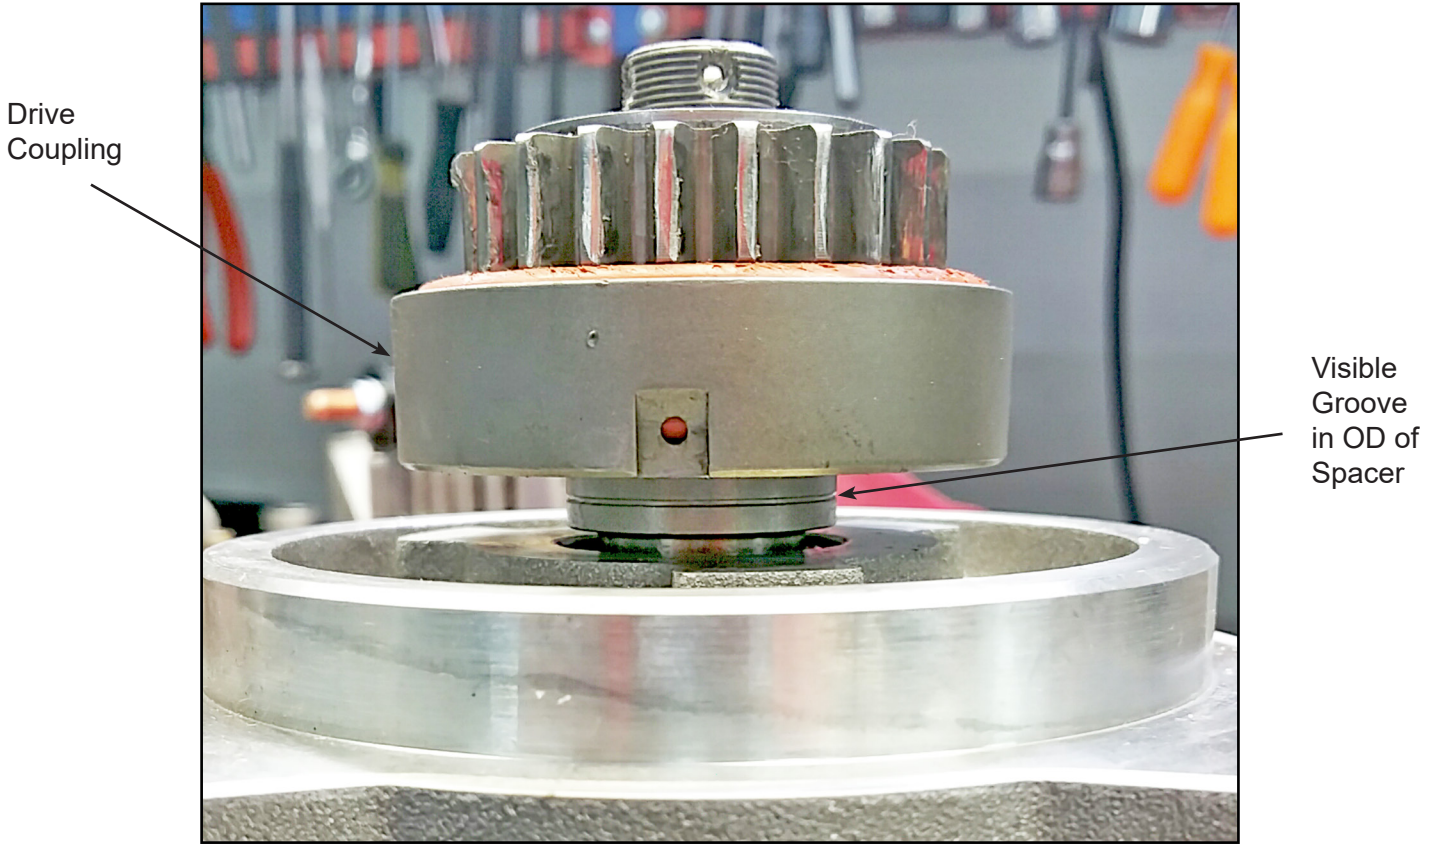
Figure-1 - Spacer Inspection

- (a) Remove the affected alternator in accordance with applicable aircraft engine and airframe service instructions or maintenance manual.
- (b) Using a flashlight, visually inspect the spacer between the alternator and alternator drive coupling. Refer to Fig. 1 thru Fig. 1b
 - 1) If the spacer **does** have a visible groove in the OD as shown in Fig. 1, no further maintenance is required.
 - a) Install the alternator in accordance with applicable aircraft engine and airframe service instructions or maintenance manual. Continue to 3C. Return to Service.
 - 2) If the spacer **does not** have a visible groove in the OD as shown in Fig. 1, replace the spacer in accordance with below instructions, 3 B. (2).

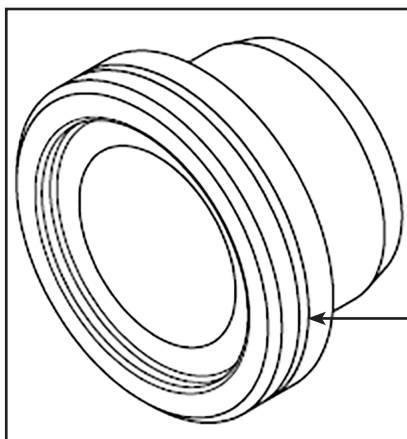
Figure-1a - Correct Spacer
P/N 41151

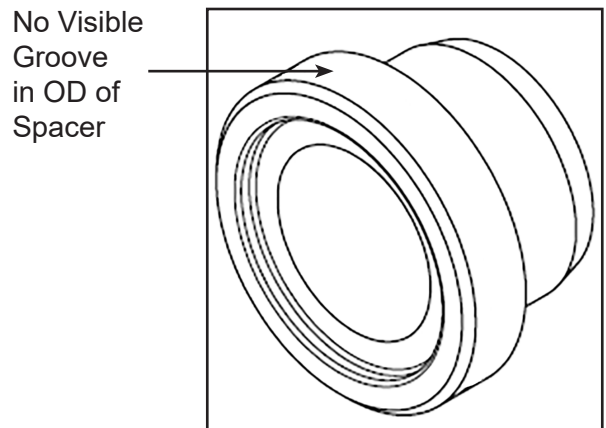
- (1) Hartzell Engine Tech has discovered that affected alternators may have been shipped with an incorrect spacer.

- (a) This condition may result in improper drive coupling retention and could result in the loss of alternator function and the introduction of metallic FOD into the engine.

Figure-1b - Incorrect Spacer
