TITLE Installation Instructions

C28-150, C14-100, C28-150S, C14-100S Installation Instructions

NUMBER 15-1000	REVISION H	PAGE 2 of 3					
TITLE Installation Instructions

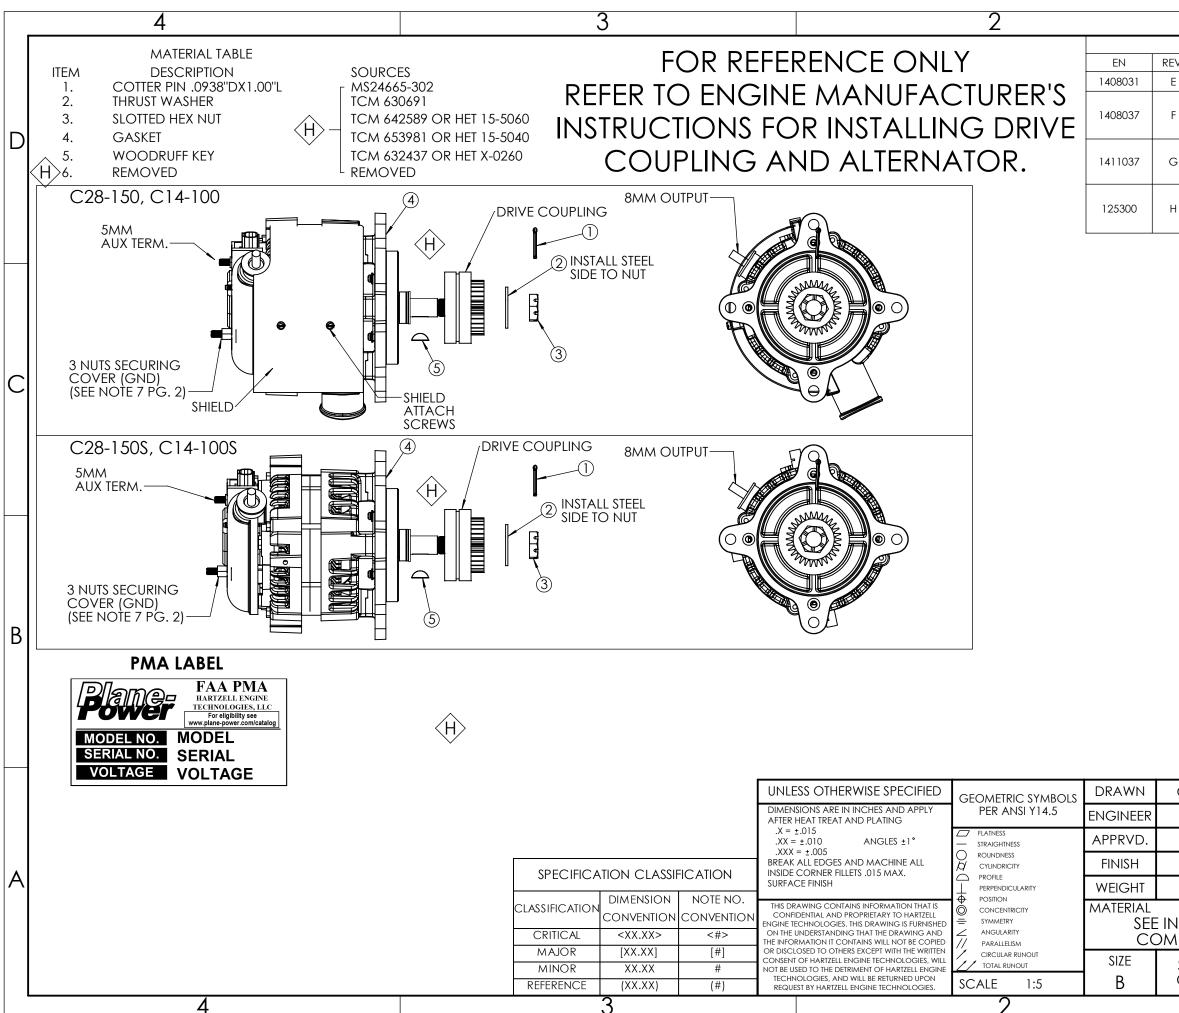
- \oplus 1. Gain access to the location where the work is being accomplished.
- \emptyset 2. <u>Label</u> then remove wiring from the existing alternator. Remove the alternator.

- Ø 3. Remove drive coupling and install it on the Plane Power alternator or install a new coupling of approved type per engine manufacturer's instructions.

- \varnothing 4. Install the alternator on the engine per engine manufacturer's instructions.
- Ø 5. Cut the ring lug off of the wire removed from the F or F1 terminal (Field) of the original alternator or generator. Connect the wire to EITHER white wire from the supplied 15-5050 Wire Harness/Plug using an M7928/5-4 environmental splice.

- Ø 6. If a second Field wire (F2) was removed, connect it to the other white wire from the supplied 15-5050 Wire Harness/Plug using M7928/5-4 environmental splice.

- Ø 10. Place the ring lug of the "+" wire (large alternator output wire), and any other wire removed from the output (+) terminal of the original alternator on the M8 output bolt of the alternator. Torque the M8 nut to 45-50 in-lbs. If currently installed ring lug is not sized for M8 stud, remove existing lug and replace with an M7928/1-44 lug. Similarly modify all other existing wire attached to the "+" post of the original alternator or generator.
- ⊗ 11. Removed
- \varnothing 12. Start aircraft and check the alternator output for proper operation.
- ⊕ 13. Recheck and inspect the entire installation. Complete FAA form 337, make appropriate log book entry, update the aircraft equipment list and revise weight and balance if necessary.
